# ON-LINE REFRACTORY CONFIRMATION FINAL REPORT

McCloud J. Ford

DE-FC26-02NT41584

MSE Technology Applications, Inc. Mike Mansfield Advanced Technology Center 200 Technology Way P.O. Box 4078 Butte, Montana 59702

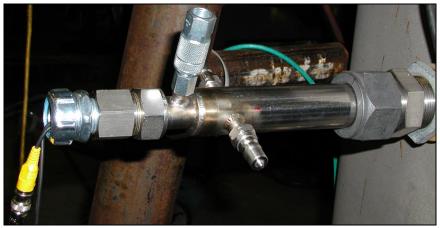
Figure 3. PC79 series pinhole camera.

The high-temperature CCD camera consists of an off-the-shelf miniature or pinhole video camera and a liquid-cooled housing designed by MSE. The camera has a 1/3-in. color 512 X 492 pixel image with a 1/100,000 shutter speed and auto iris. The camera body is 20 mm in diameter and 57 mm long with a 3.6-mm, 80-degree lens (Ref. 2). MSE purchased the PC79 series pinhole camera (Figure 3) from Super Circuits (www.supercircuits.com) who claim it is one of the world's smallest CCD video cameras. The camera housing (Figure 4) consists of a double-wall tubular stainless steel jacket that protects the camera from high temperatures up to 1,650 °C. The camera housing can hold different lens filters and also has small voids in front of the lens to allow gas purging of debris that may accumulate. Normally, water flows through the housing jacket to maintain a cool operating environment for the pinhole camera. MSE

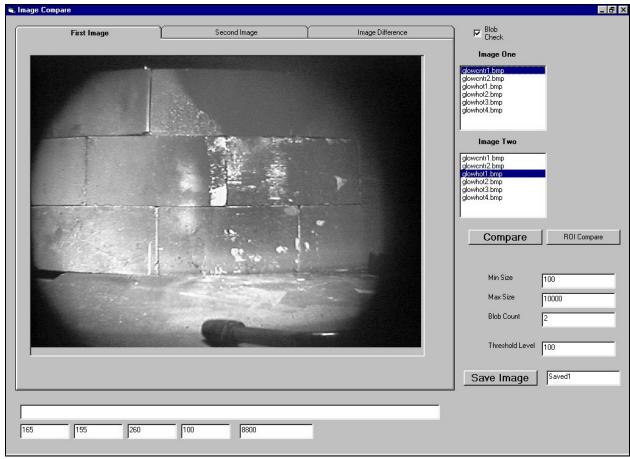
Figure 8. Windows interface screen.

The Windows interface screen (Figure 8) the MSE engineers created for this test was simple and concise, but effective. This is a common-looking Windows screen with tabs, buttons, information boxes, and a selection list. Although the window lacks some box description labels, this program could be easily operated by anyone familiar with mouse functions on a Windows screen.

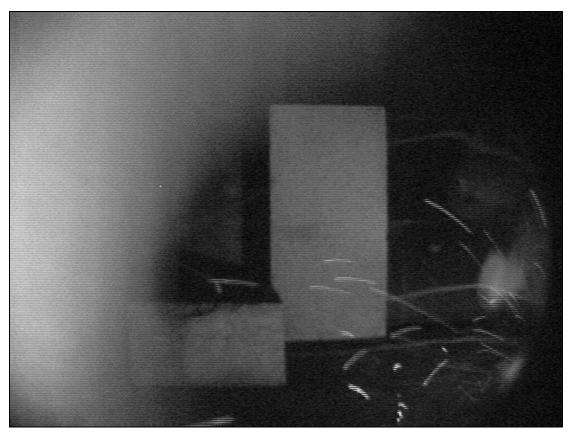
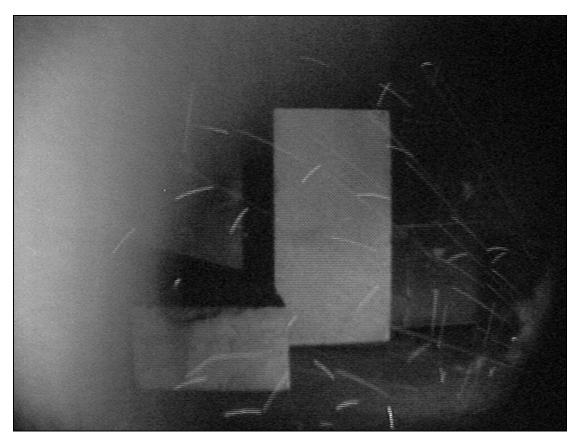
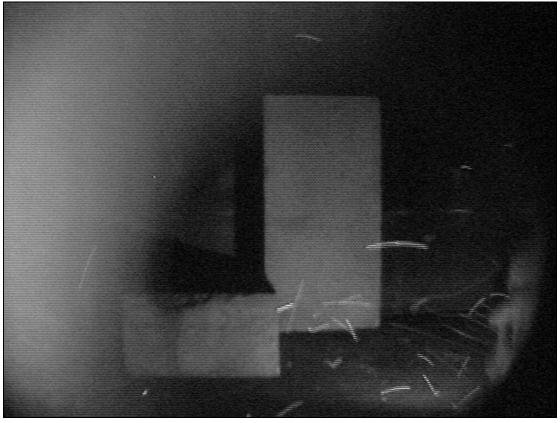
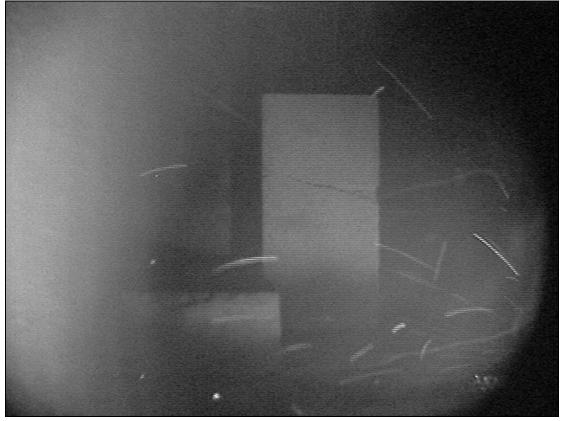
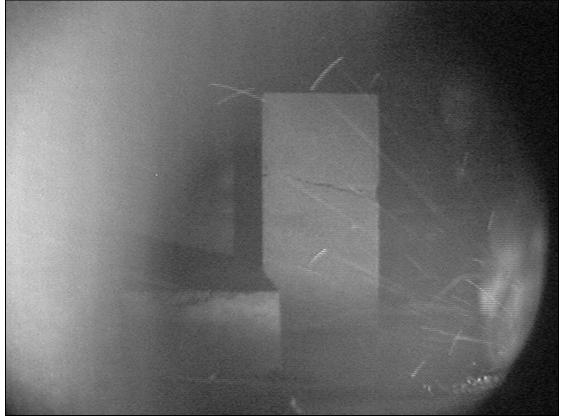
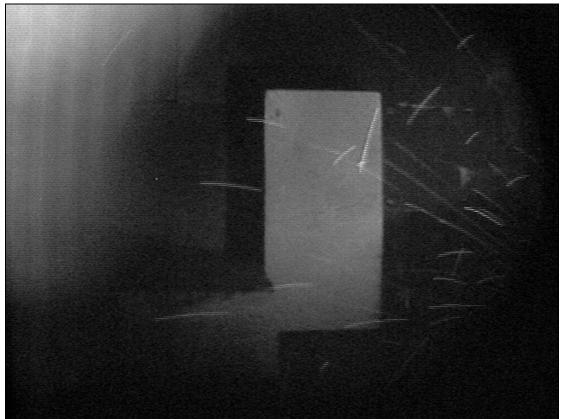
Intense Light Capability Images

An arc welding rod activated inside the chamber on the steel plate jig directly in front of the firebrick provided fairly intense light to the CCD pinhole camera. The camera housing accepts filters fitted in front of the lens to attenuate light. These filters are Tech Spec<sup>TM</sup> reflective neutral density filters (Figure 17), which are often used in laser and photometer applications where excessive power can cause inaccurate results (Ref. 6). A Number 2 optic density filter with 1% transmission and 44% absorption shielded the CCD camera from the intense arc welder light. The frame grabber recorded four images of a perfectly

good brick under the intense light conditions at increments of approximately 5 s. This same firebrick received characteristic change in the form of slag or slag deposit and a small crack. The frame grabber again recorded images at increments of approximately 5 s. The compare program looked for pixel change from the undamaged brick under the ROI method (Figure 18) to eliminate interference from arc welding rod debris.

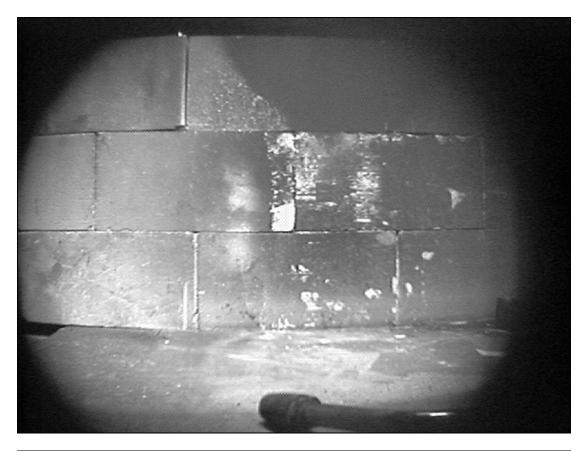
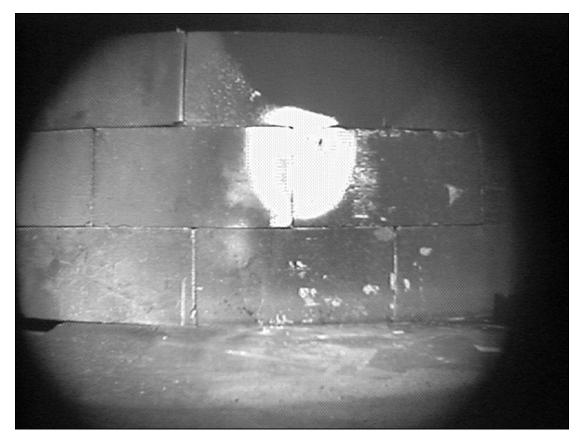
Hot Spot Recognition Images

Concentrated heat in one area (hot spot) of the refractory could pose a hazard to the integrity of the gasification chamber wall. When this hot spot occurs, the refractory undergoes a color change that is easily picked up by the pinhole camera and the frame grabber. For future testing, it may be interesting to use an infrared camera as a primary image sender. The frame grabber is capable of recording any type of image and the compare program converts the image into gray contrast pixels regardless of the source. The infrared camera could be valuable for detecting temperature changes in certain areas of the gasification chamber.

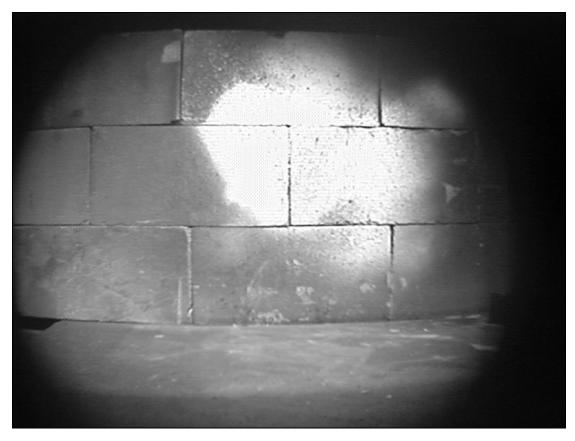
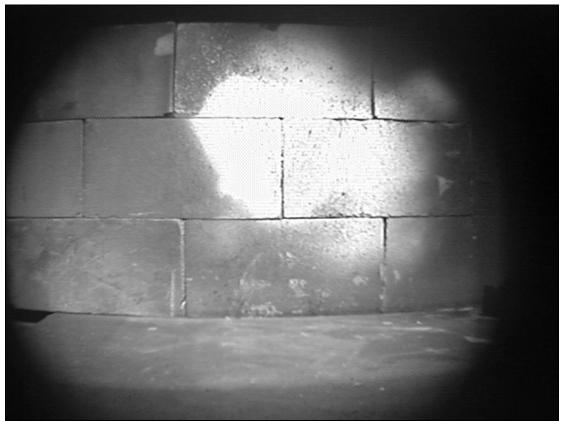
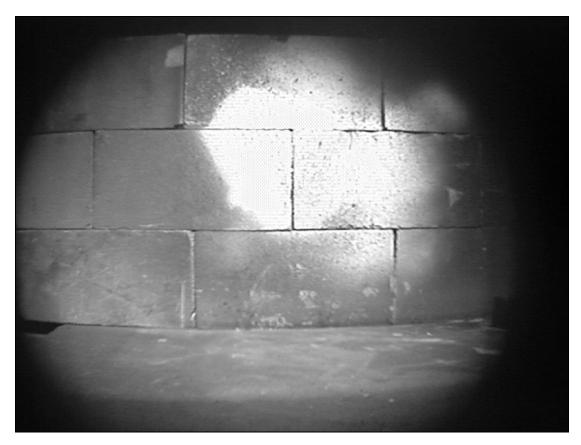
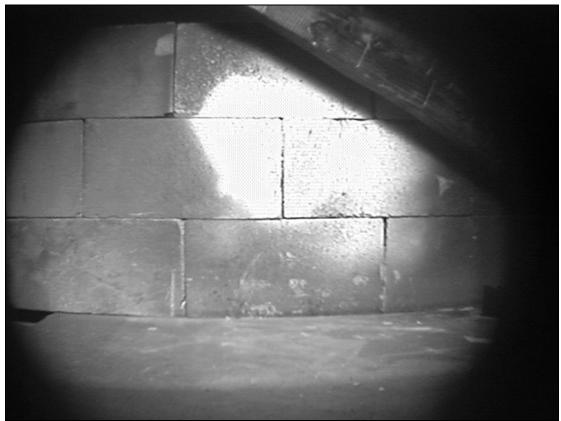
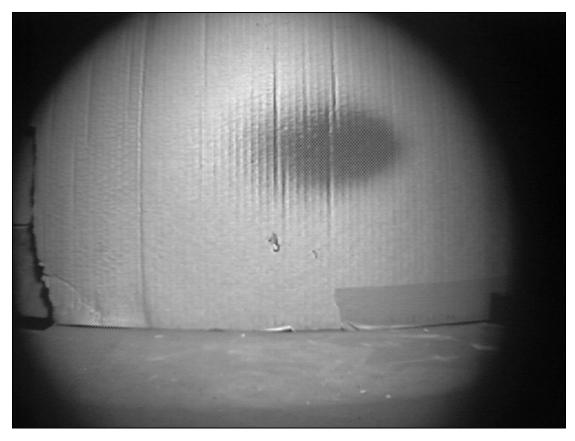
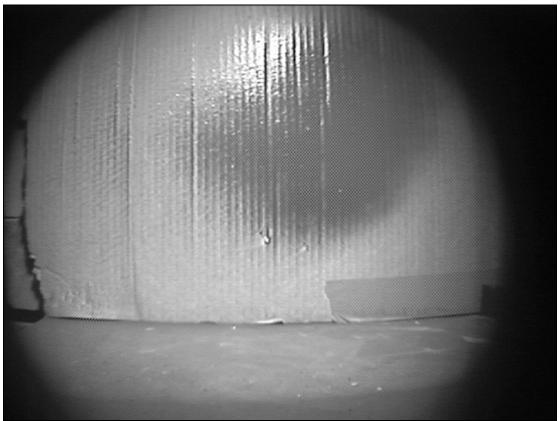
Streaming Image Mode Images and Data

This test run simulated conditions that may be encountered in an incinerator or gasification chamber. In this case, the oxy acetylene flame did not produce enough light fluctuation to hinder the compare program. However, if the light from a flame in a gasification chamber was not as steady, the flickering light could produce false results in the compare program. Some programming modifications would eliminate this potential problem. The frequency or frame grabber image capture cycle can cover a large range of time intervals. A particular cycle time could eliminate the false image change. The software also has the ability to compile a series of images and average the pixel count for the entire series. This method could also eliminate light fluctuation problems by averaging the pixel change over a long series of images. The section titled Streaming Image Mode explains the advantages of this method in more detail.
